## AMENDMENT NUMBER ONE

**Schematic Design Study  
Improvements to Wichita Art Museum  
Wichita, Kansas**

3 February 2006

## **Site Inspection**

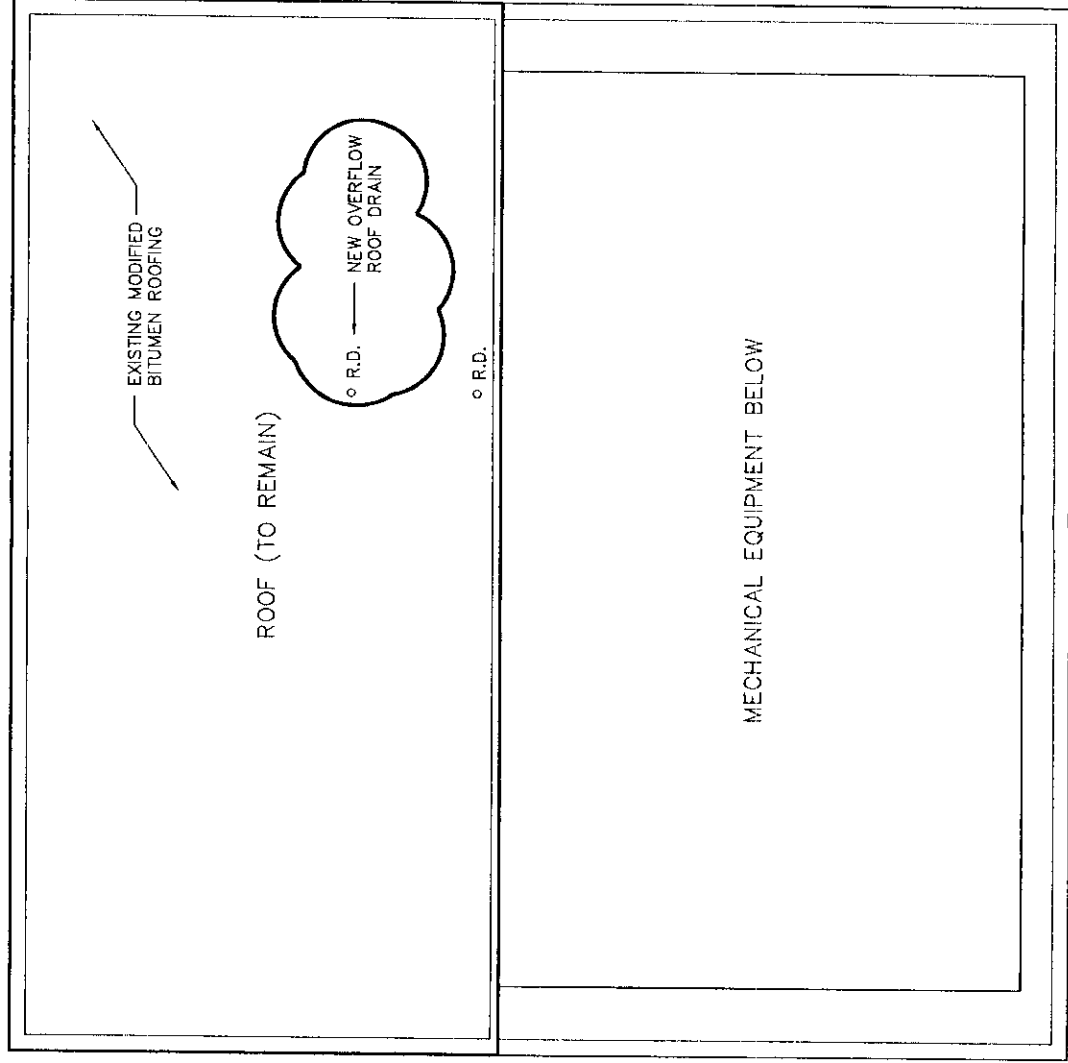
## A2.0

- ▶ The chiller area roof is of a very low slope, if not flat, and ponds water and ice. There is no overflow roof drain in the event that the primary drain clogs.

- ▶ The penthouse roof slopes to a primary roof drain, but there is no overflow roof drain in the event that the primary drain clogs.

- ▶ Install new overflow roof drain.

- ▶ Remove existing roofing system.
- ▶ Install raised curb and cant at corrugated metal wall to allow increase in roof slope.
- ▶ Clean existing roof drain and piping piping.
- ▶ Install new tapered insulation system, roofing and metal flashing.
- ▶ Install new overflow roof drain with interior piping.

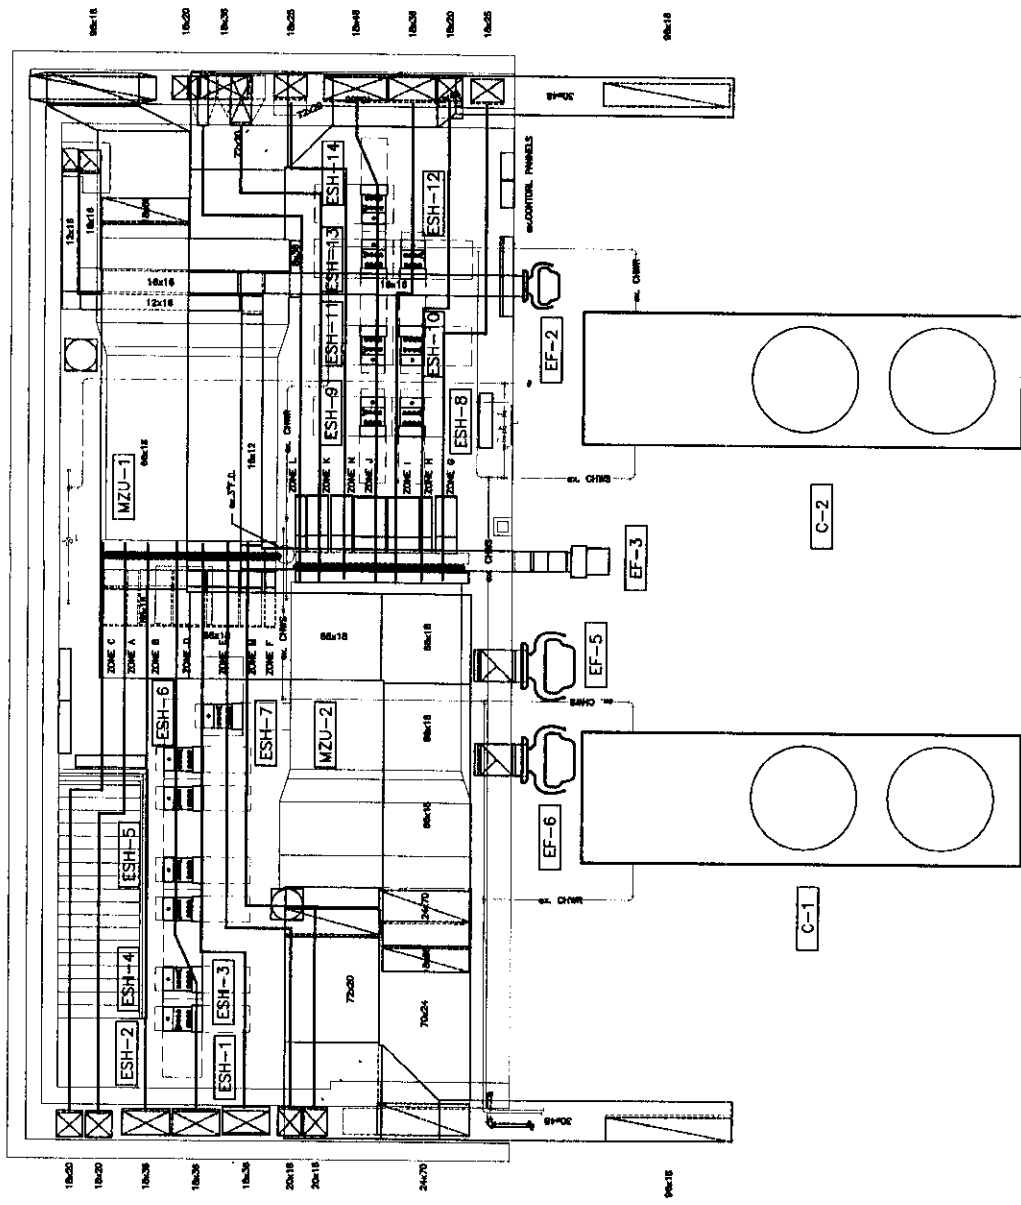
M1.1

- ▶ The steam humidification system, as designed, is not suited for zone humidification and has deteriorated to the point where it is not serviceable.
- ▶ The MZU's show some rust damage, but are generally serviceable. Currently one of the MZU's is receiving a new motor and belts. The motor for the other MZU was replaced within the past two years.

- ▶ Remove and replace chilled water coils in MZU-1 and MZU-2.
- ▶ Install stainless steel drain pan in bottom of each MZU.
- ▶ Field fabricate air mixing housing and bag filter housing for each MZU. Insulate housing. Replace existing bag filters.

- ▶ Remove existing steam and condensate piping, exhaust fans 2,3 and associated ductwork.
- ▶ The existing heating electric heating coil for each MZU, HC-1 through HC-14 to remain. Repair/replace electric heating coils that are not in working condition.

- ▶ Verify how the MZU's are being controlled with the City's Temperature Control Contractor and make necessary interface.
- ▶ Install individually zoned electric humidifiers. Locate the humidifiers in the penthouse below the zone (ducts) it serves. Locate the humidistats in the space that the zone serves.
